Lake Illawarra entrance channel: data compilation

WRL TR 2022/25, November 2023

UNSW
Water Research
Laboratory

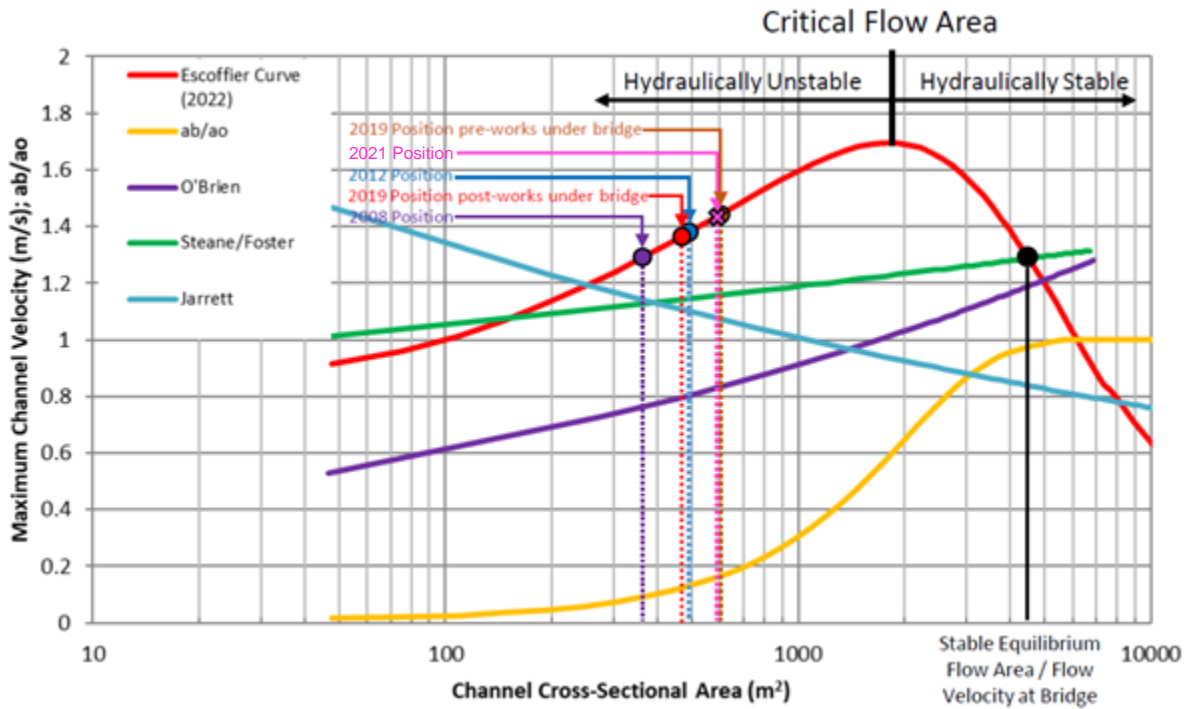
Figure 2.6 Lake Illawarra inlet stability curve at Windang Bridge (Adapted from MHL, 2023b)

area is reached, the ratio of the lake to ocean spring tidal range would have increased from 0.14 (December 2021) to 0.97 (i.e. the lake tidal range would be approximately equal to the ocean tidal range).

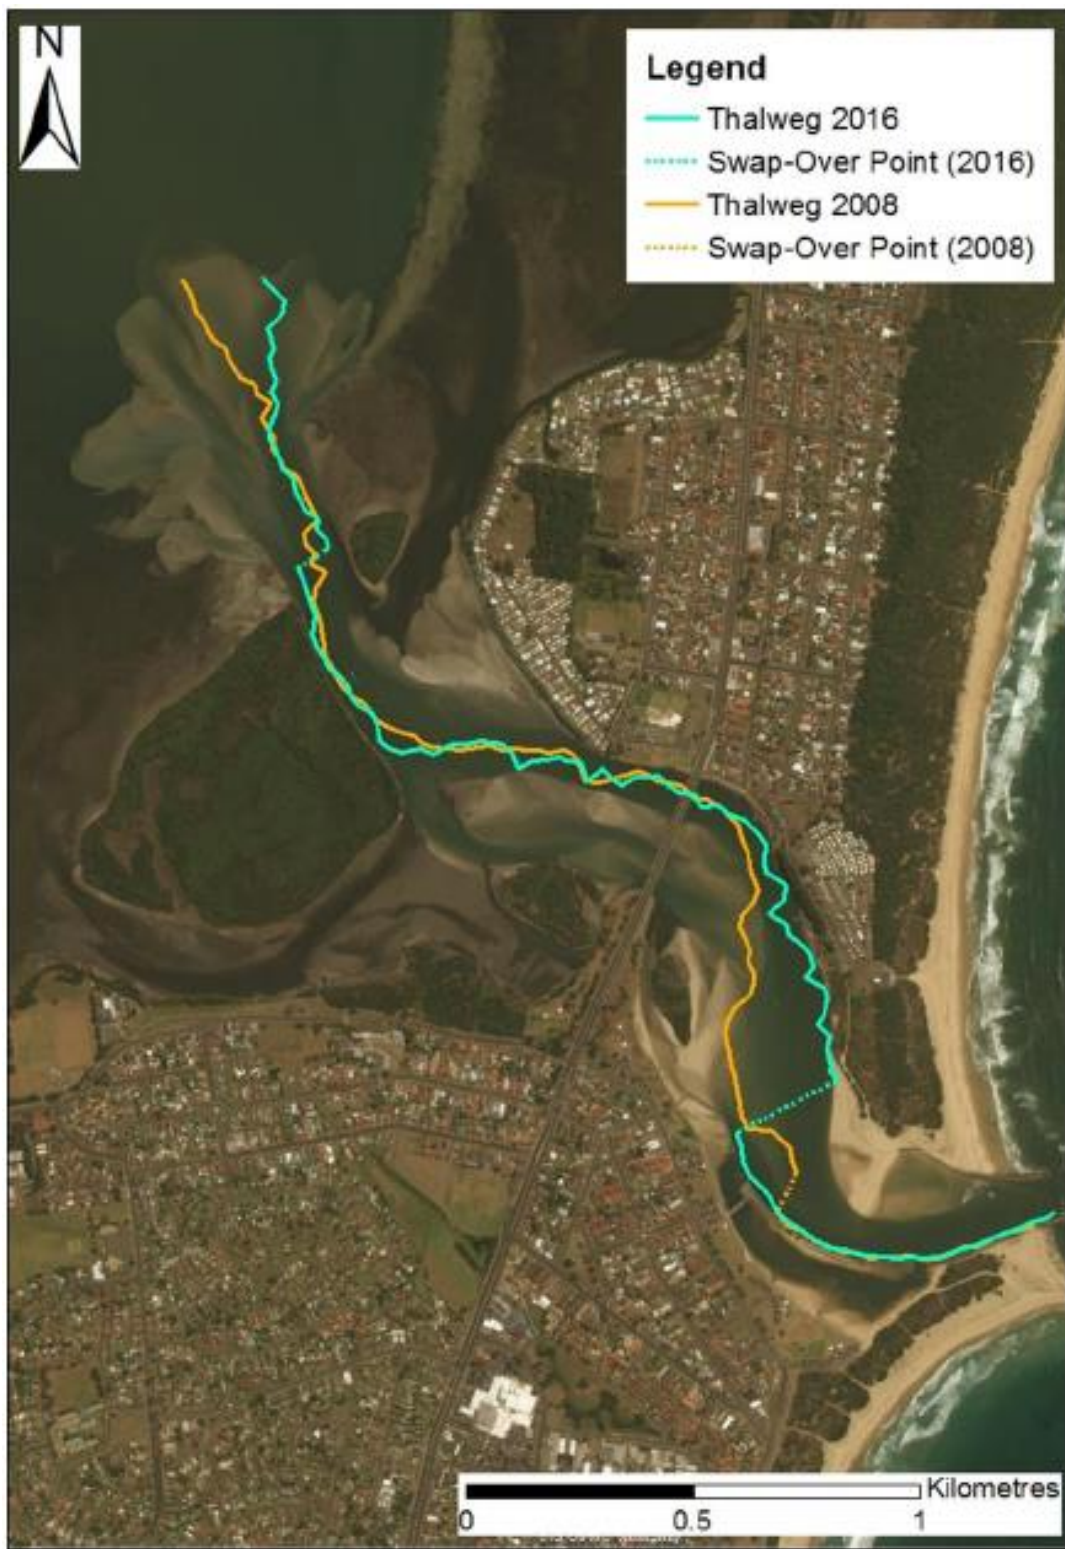
**Figure 2.8 Position of the thalweg, based on 2008 and 2016 hydrographic surveys
(Source: Regena, 2016)**

As a result of the movement of the channel thalweg, significant erosion began to occur along the Windang foreshore near the boat ramp and Pine Tree Park boardwalk. In 2012, LIA, in conjunction with WCC implemented protection works to limit the erosion, including adding additional piles to stabilise the Pine Tree Park boardwalk and construction of three rock groynes. The estimated cost of the rock

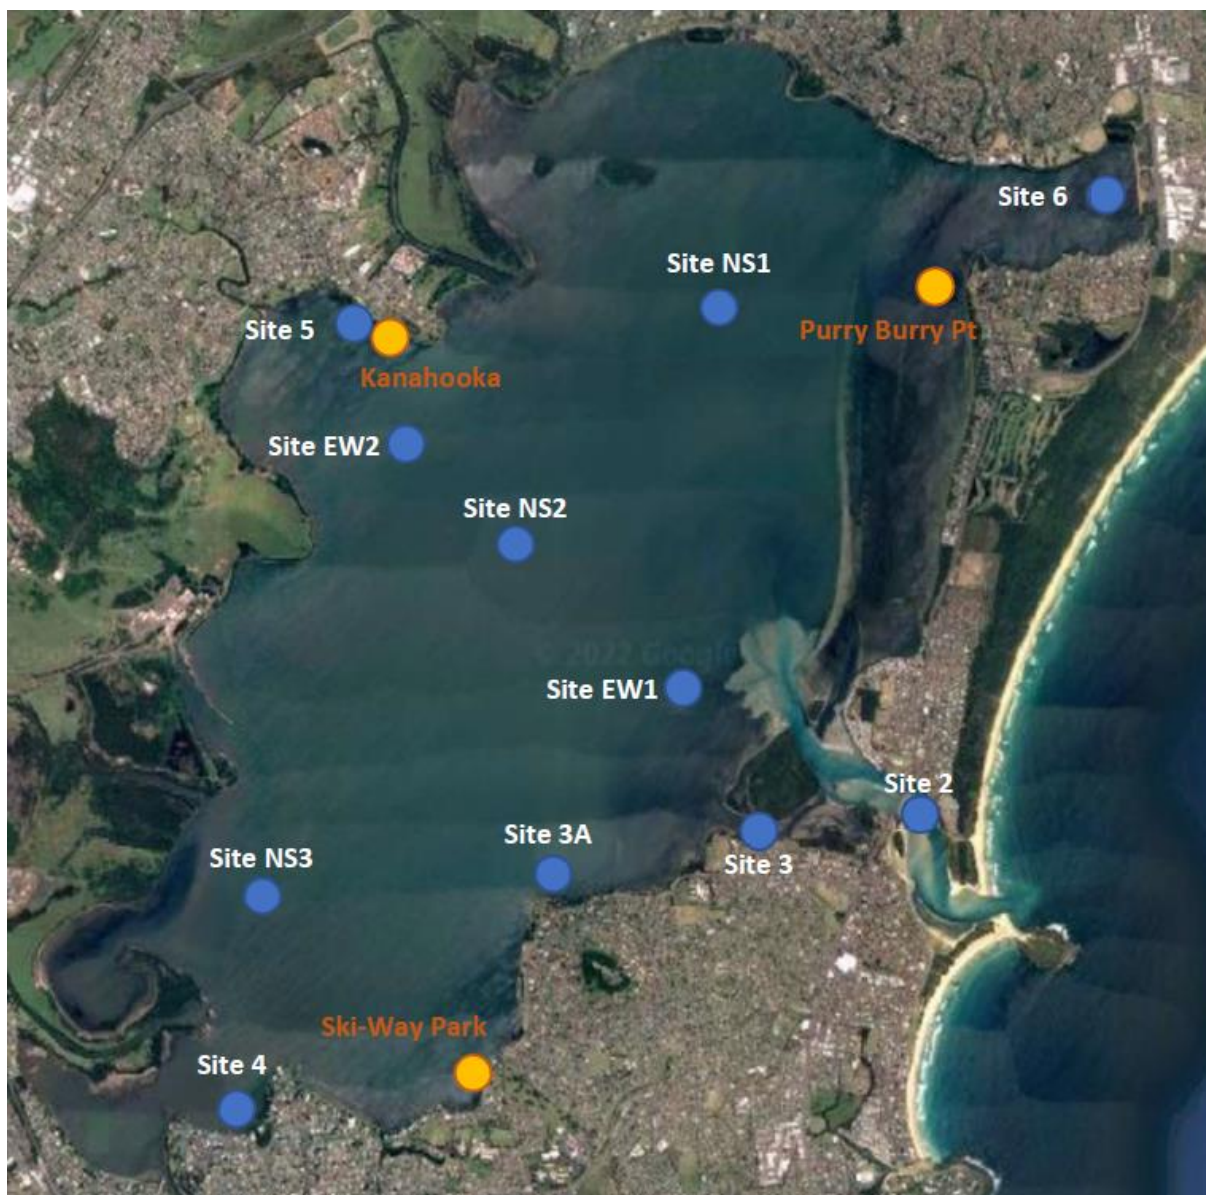
Figure 2.9 WCC and SCC water quality monitoring locations (blue = ecosystem health, orange = recreational suitability) (Source: WCC, 2022)

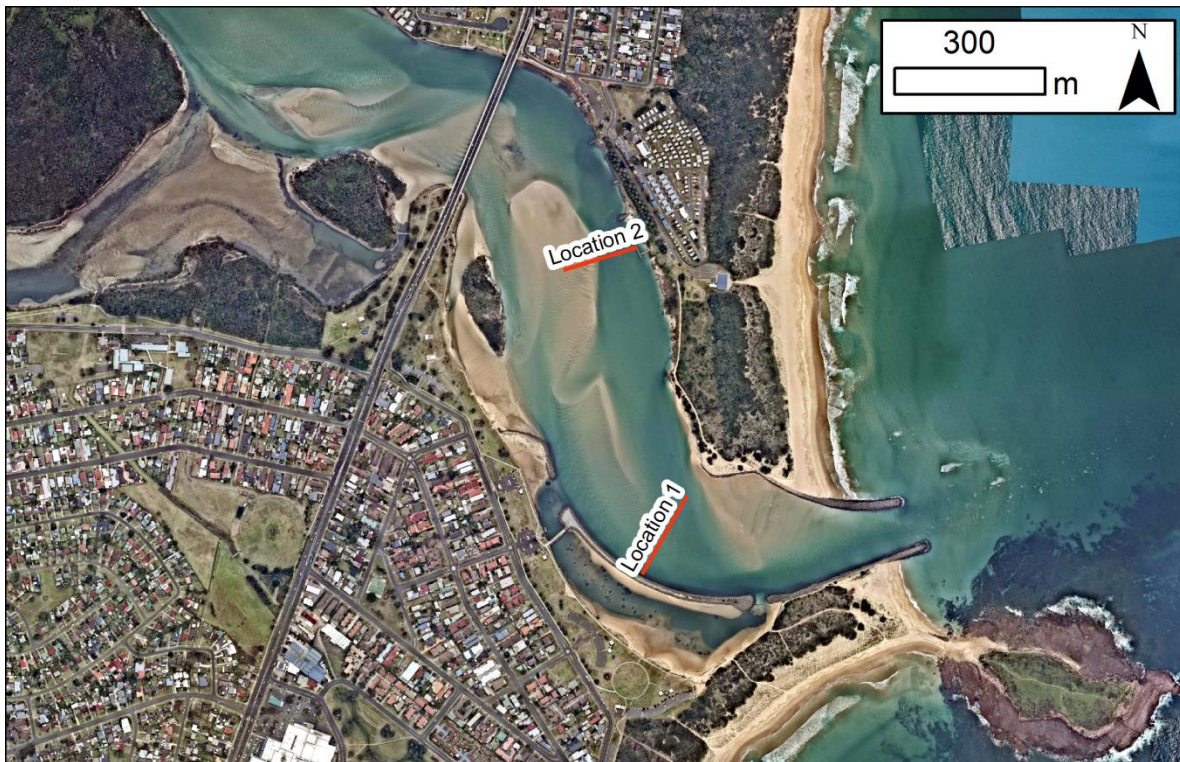
Figure 2.12 Approximate MHL tidal flow gauging transect locations

Tidal gauging was completed using a RD Instruments Workhorse Acoustic Doppler Current Profiler (ADCP) (gauging complete by MHL and WRL) and a Sontek RiverSurveyor-M9 (for gauging completed by WRL). These instruments measure velocities throughout the water column as a vessel moves perpendicular to the flow direction. By completing multiple transects across a water body, discharge throughout time can be measured. On each of the seven gauging exercises, between 30 to 45 transects throughout the tidal cycle were completed to reconstruct the discharge signal. While the measurements were taken at approximately the same location in 2008, 2016, 2018, 2019 and 2020 (Location 1 in Figure 2.12), the 2012 measurements were further upstream near Berageree Island (Location 2 in Figure 2.12). As shown in Table 2.2, there were also differences in the offshore tidal range during each of the seven exercises.

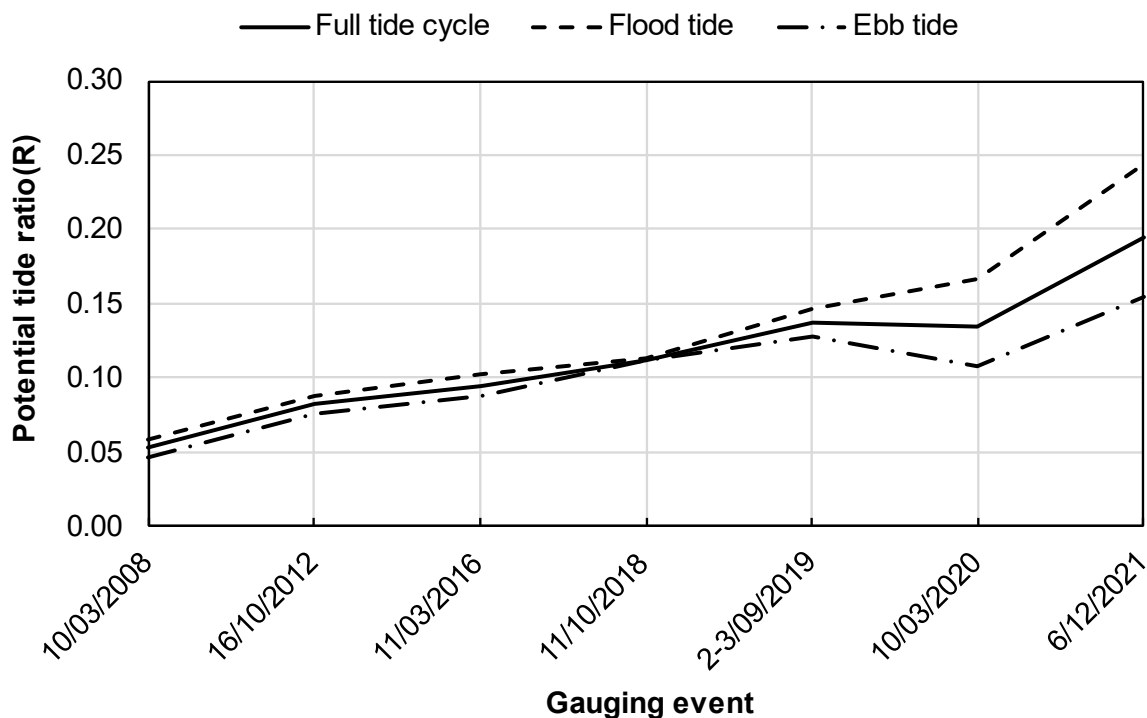
Figure 2.13 Change in the potential tidal ratio between tidal prism measurements

By solving Equation 2.1, each of the seven tidal gauging measurements can be compared (noting the assumptions used to develop the potential tide ratio). These results are presented in Figure 2.13.

The results show that the tidal prism within Lake Illawarra has had an increasing trend between 2008 and 2021 due to increased conveyance through the entrance channel which has resulted from the permanent entrance opening. Where originally 5% of the potential water volume passed through the entrance channel, now almost 20% of the potential water volume passes through. Note, the potential tidal ratio decreased on a single occasion on the ebb tide for the 2020 gauging event. The decrease could be due to the assumptions underlying Equation 2.1, the time within the tidal cycle when tidal gauging was completed (i.e. spring/neap cycle), and/or the uncertainty related to data collection ($\pm 5\%$ of the tidal prism).

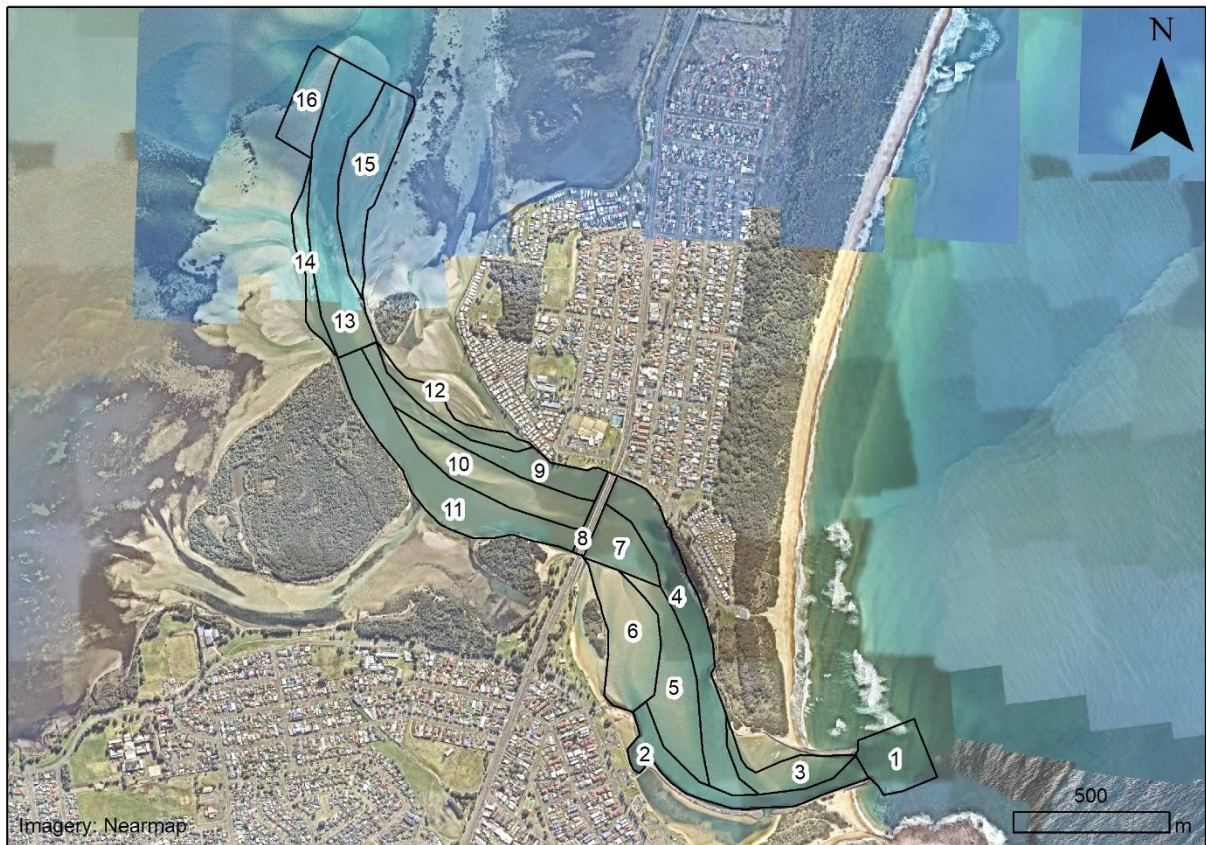
Figure 2.16 Lake Illawarra entrance channel sediment compartments for erosion analysis

To identify erosion “hot spots” an analysis was completed where the Lake Illawarra entrance channel was divided into 16 sediment compartments (Figure 2.16). Results of this analysis showed that the rate of erosion across the entrance channel varies significantly (see Table 2.5 and Figure 2.17). Some areas experienced significantly higher rates of erosion (sediment compartments 2, 4 and 11) while other areas experienced accretion (sediment compartments 6 and 16). Sediment compartment 2, along the Windang foreshore, had the highest rate of sediment change with average erosion of more than 0.2 m per year between 2008 and 2022. While WRL considers that wave-driven marine sediments are still likely being transported into the entrance channel, the net negative sediment change rates for compartments 1 to 5 near the entrance indicate that scour from tidal velocities is the dominant process. Note, the rate of change during the 14 year period during which the entrance bathymetry has been monitored is variable over time and between compartments. For reference, the volume change over time for each individual sediment compartment shown in Figure 2.16 has been provided within Appendix D.

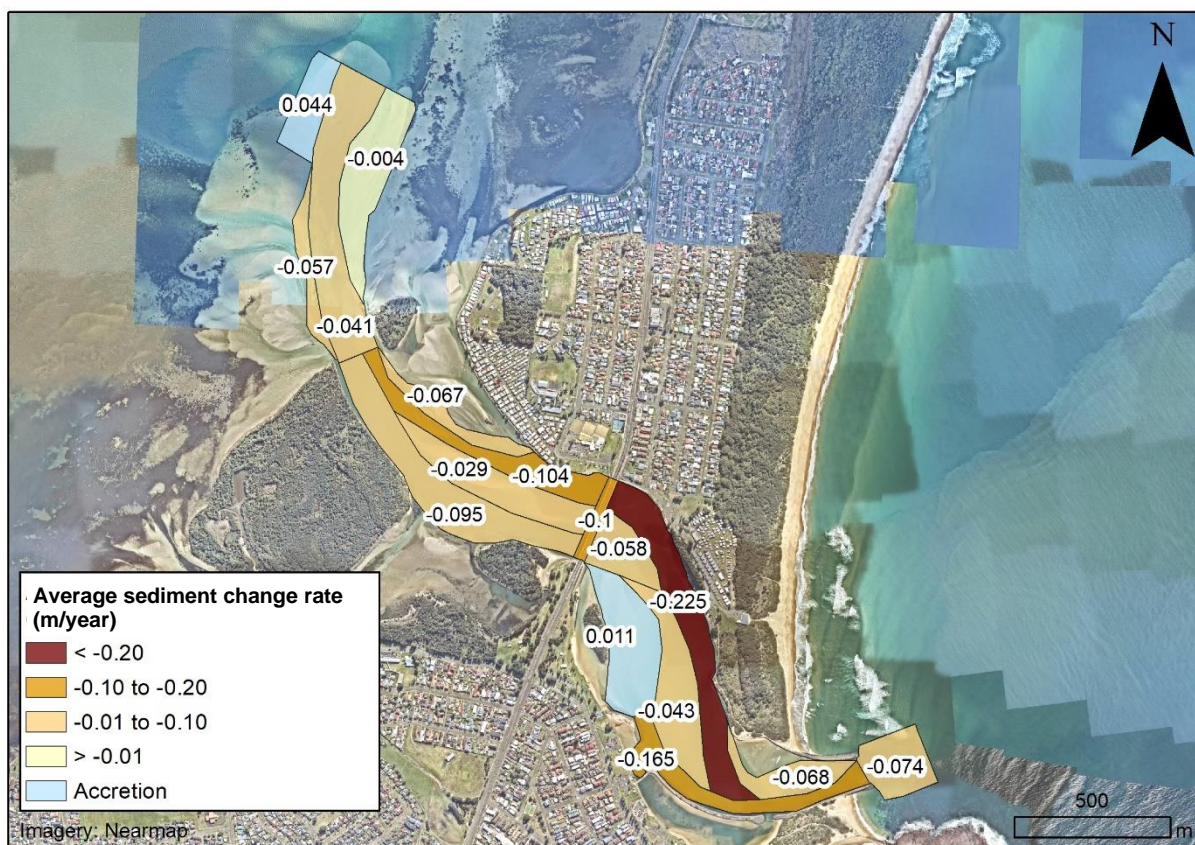
Figure 2.17 Average annual sediment change rate within each sediment compartment of the Lake Illawarra entrance channel

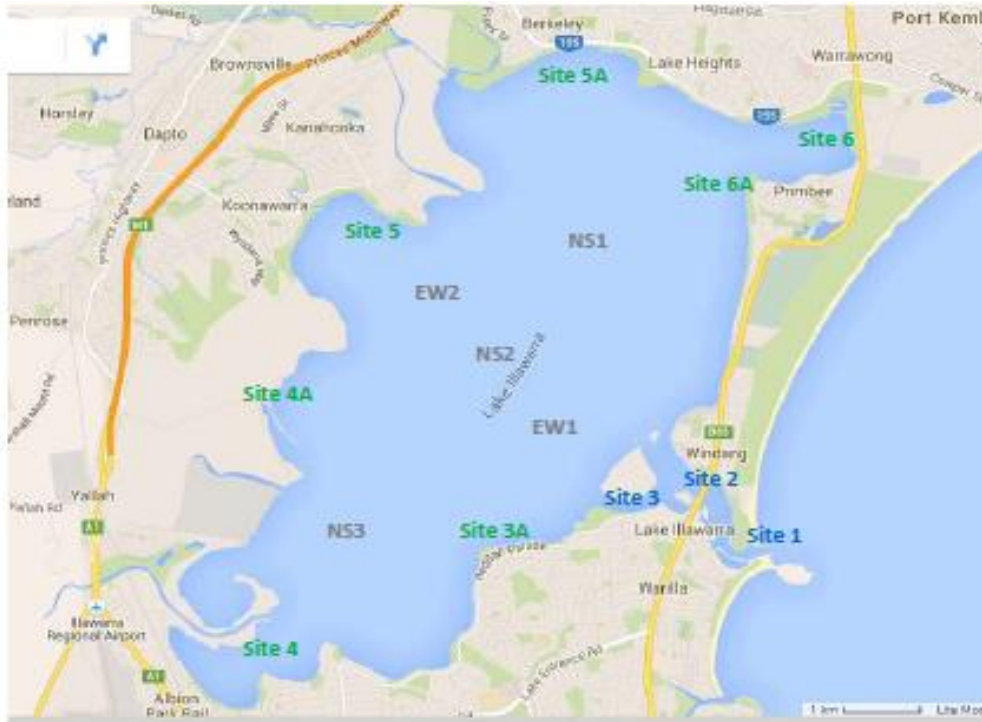
Figure 2.21 WCC and SCC water quality monitoring sites (WCC, 2017)

Figure 2.21 and Table 2.6). WCC and SCC stopped collecting data at Site 1 after December 2017 because of safety considerations, as access to Site 1 required climbing down over training wall rocks which had become unstable (WCC, 2018). However, WCC and SCC concluded that this was not a major drawback for the water quality monitoring program, as Site 2 was considered to have similar water quality to Site 1 (WCC, 2018). Since the 2018/19 summer, water quality is assessed for recreation at three new sites (previously shown in Figure 2.9; WCC, 2022). A summary of water quality data collected by WCC and SCC is provided in Table 2.7.

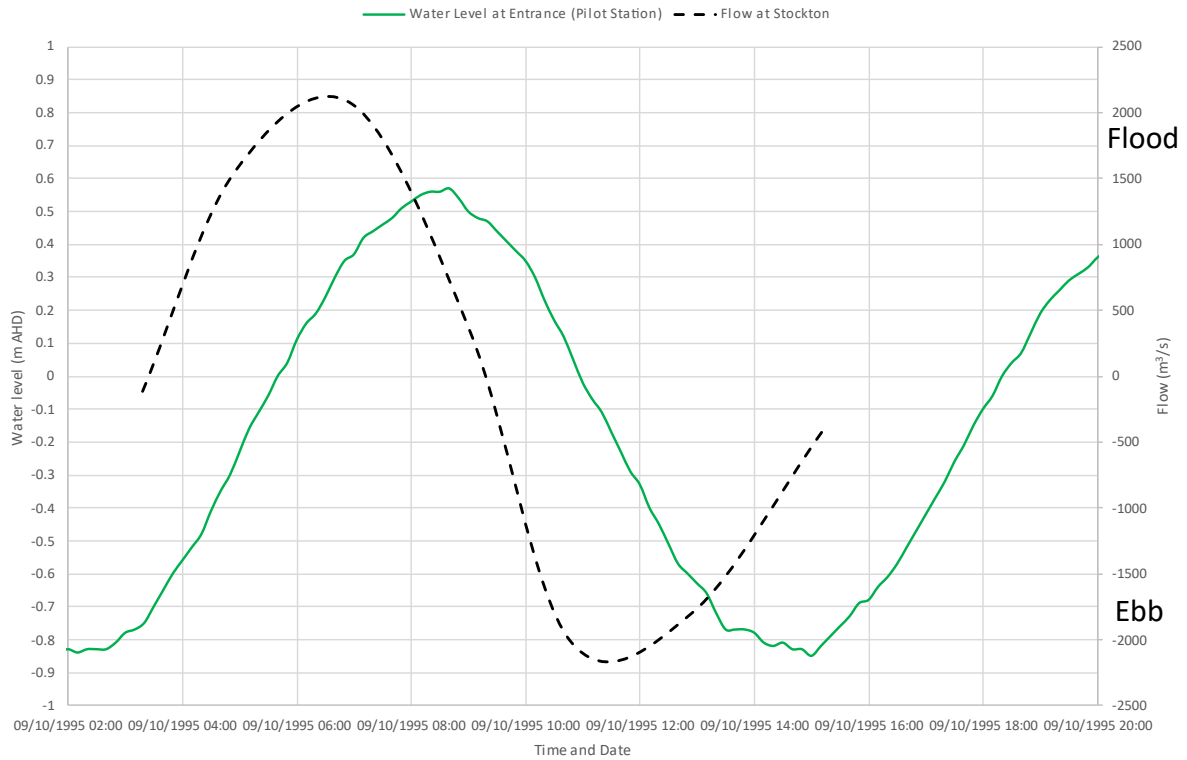
Figure 3.2 Hunter River estuary – comparison of gauged tidal flow with measured ocean water level 9 October 1995 (Adapted from MHL, 1996) – upstream flow (flood tide) is positive

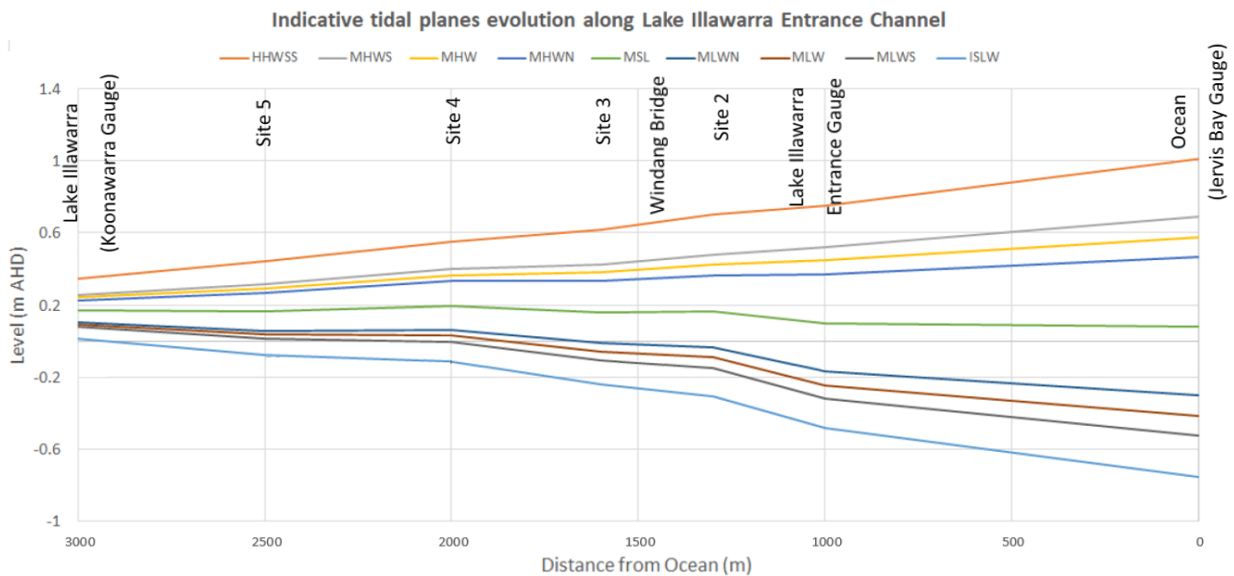
Figure 3.4 Indicative tidal planes evolution along Lake Illawarra estuary channel (Adapted from MHL, 2023b)

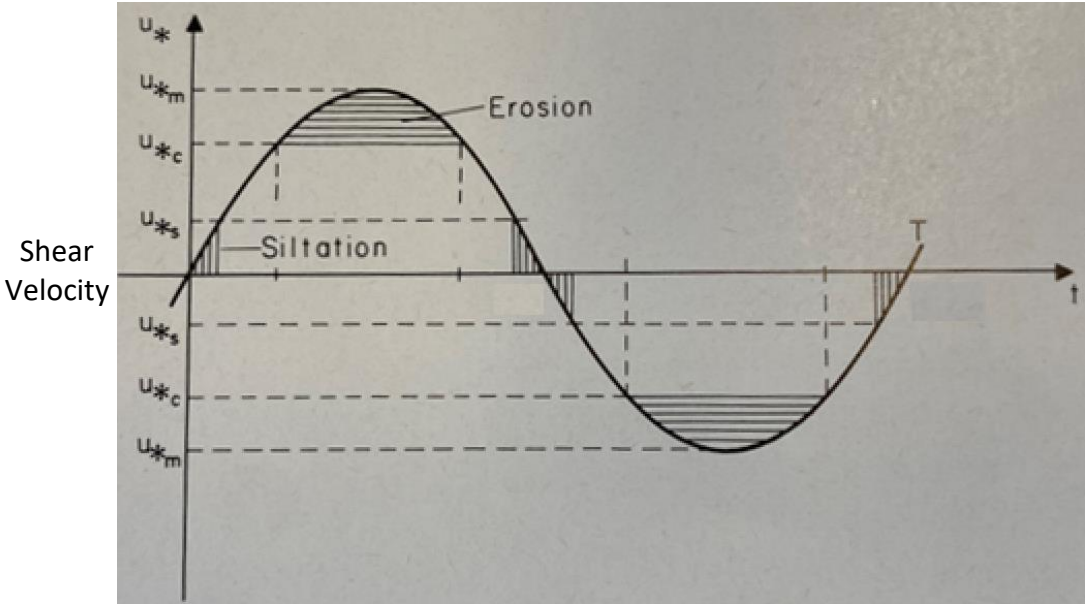
Figure 3.7 Sequence of erosion and siltation/accretion during a tidal cycle (Adapted from Raudkivi, 1976)

While the bed and banks of the Lake Illawarra estuary channel act to modify the hydrodynamics between the ocean and the lake, the water is also modifying the bed and banks. When the shear velocity (u_* which is proportional to tidal velocity) exceeds the critical shear velocity (u_{*c}) for sediment (typically medium sand; see Section 2.3.5) in the entrance channel, erosion is expected to occur. Similarly, when the shear velocity falls below the siltation shear velocity (u_{*s}), sediment accretion is expected. In between these two values, neither accretion nor erosion occurs. This estuarine process is shown over a tidal cycle in the idealised sketch in Figure 3.7, indicating that there is potential for eroded sediment to be both transported toward the lake and back toward the ocean.

In the Lake Illawarra entrance channel, the erosion and accretion sequences are not in balance resulting in a positive feedback loop between the hydrodynamics and sediment transport. Due to the stress on the bed and banks from the high tidal velocities, net erosion is occurring in almost all compartments of
